Model Schools - Suvarna Jala

A Status Report

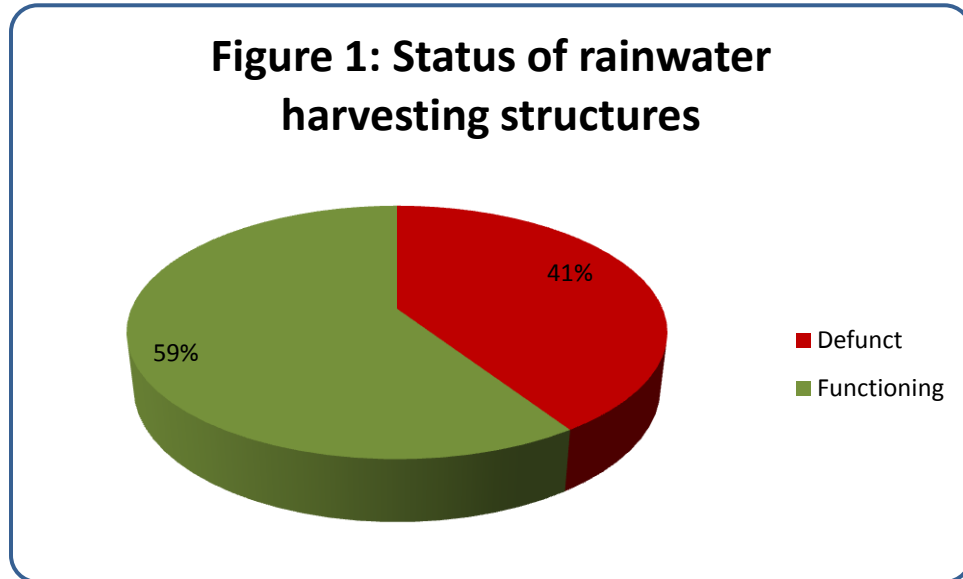
The study indicated that 16 structures are functioning and the other 11 schools (41%) are defunct (See Figure 1).

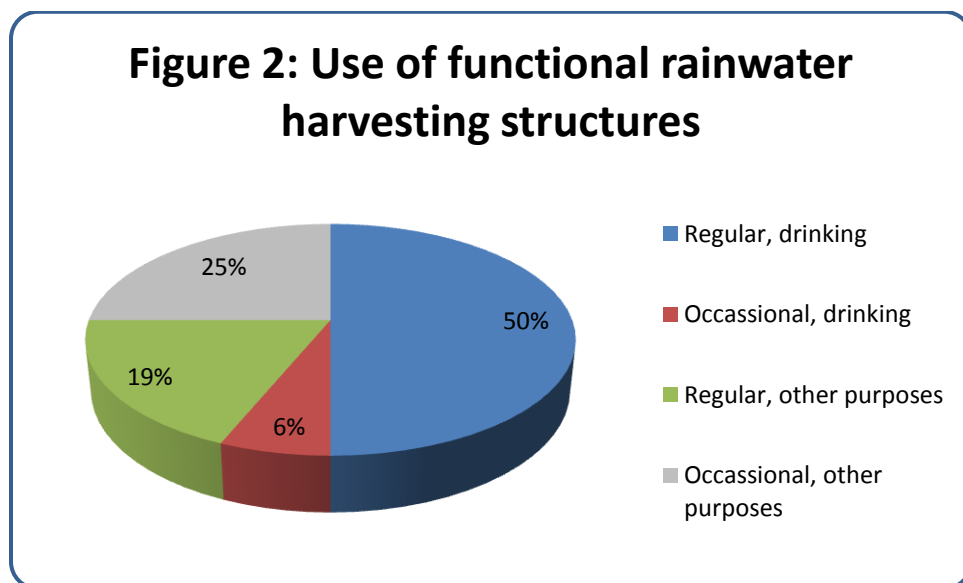
A further examination of functioning structures indicated the following usage pattern (See Figure 2):

- 8 structures - used regularly for providing drinking water
- 1 structure - used occasionally to provide drinking water

- 3 structures - regularly to provide water for purposes other than drinking
- 4 structures – occasionally to provide water for purposes other than drinking

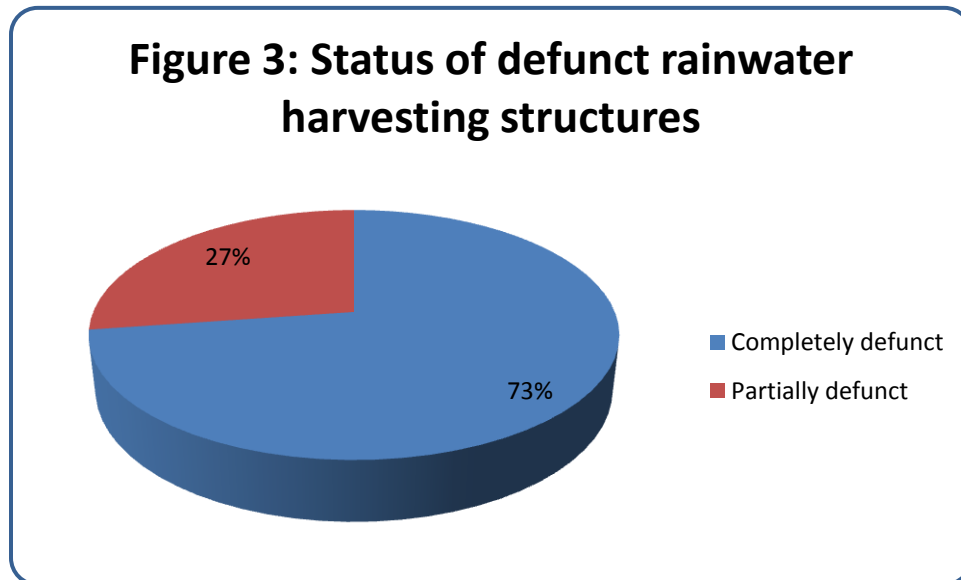
A similar analysis of the defunct structures (See Figure 3) indicates that:

- 8 structures - completely defunct
- 3 structures - partially defunct due to minor problems such as hand pump being in disrepair, etc. In some structures, it was found that though the water collected is useable, its use is prohibited/ hindered. For instance, one school in Gowdagondana halli village, Davanagere district demonstrated that though the hand pump was not working, the water could still be drawn using a bucket from the sump temporarily till repairs are carried out.

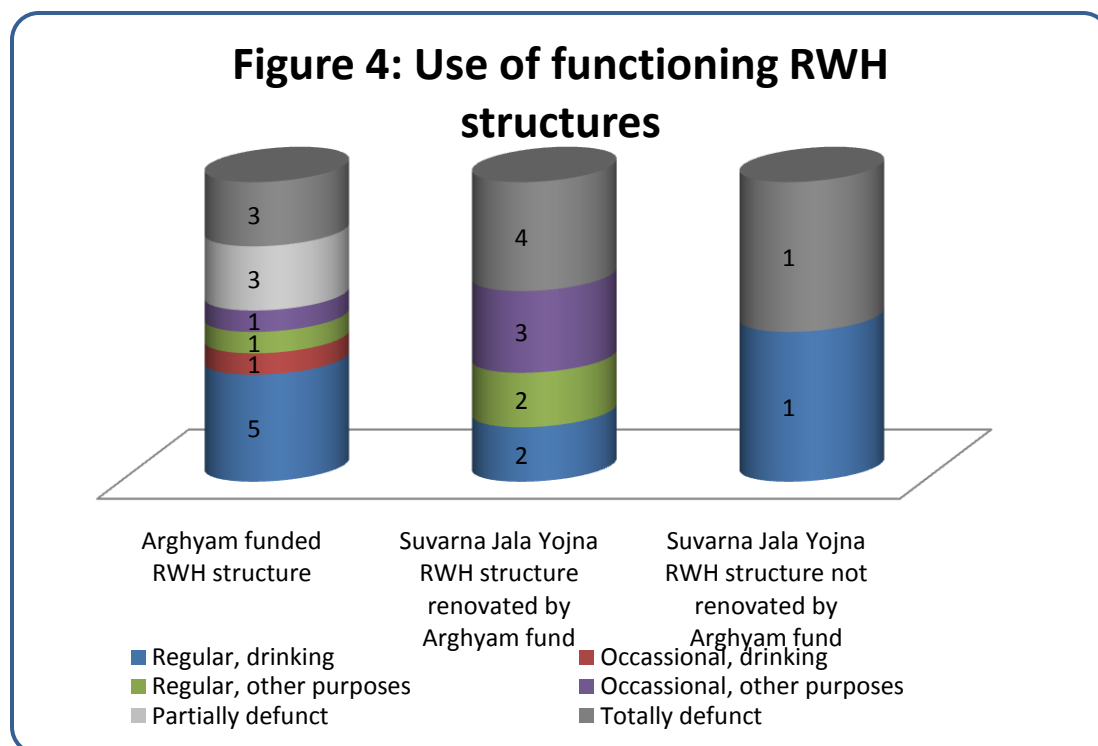
As the primary purpose of construction of the RWH structures was to provide drinking water, results are also understood based on their use (See Figure 4).

It is evident from Figure 4 that while 63% (5 out of 8) of functional RWH structures constructed using Arghyam funds are used for providing drinking water, only 29% (2 out of 7) of functional RWH structures that were constructed under the Suvarna Jala Yojana are used to provide drinking water. However, 71% (5 out of 7) of these renovated structures are used to provide water for other uses either regularly or occasionally.

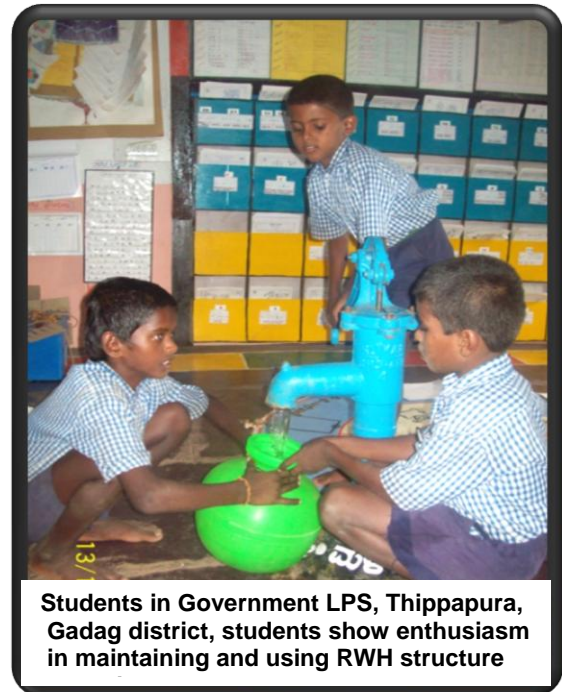
Students in Government LPS, Thippapura, Gadag district, students show enthusiasm in maintaining and using RWH structure
