**Workshop on
Success Stories
in Watershed Programmes of
Department of Land Resources**

**STATE LEVEL NODAL AGENCY /
TAMIL NADU WATERSHED DEVELOPMENT AGENCY
TAMILNADU**

DPAP - XII Batch - Kodaikanal Block -Dindigul District – TamilNadu

IWDP –VI - Guziliamparai Block – Dindigul District – TamilNadu

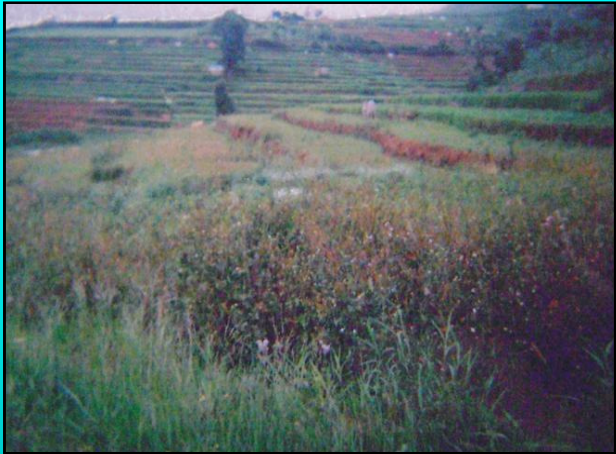
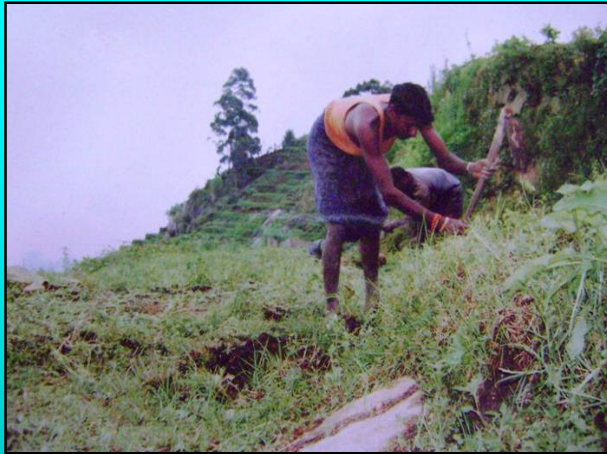
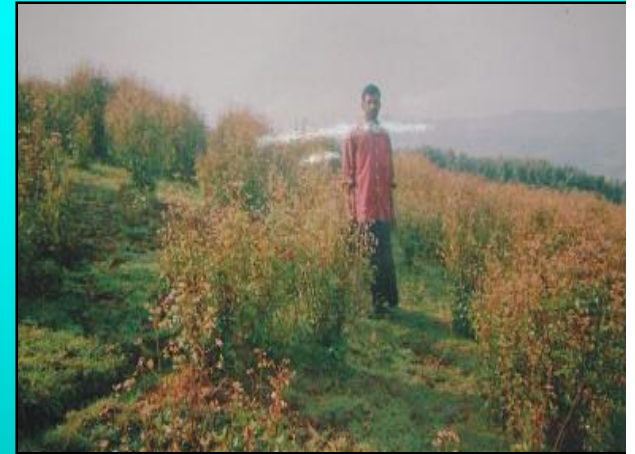
LAND LEVELLING

- The watersheds being treated are in the rainfed areas of kodaikanal block.
- The major problems are - bushes, rocks, roots of the nearby trees apart from erosion due to undulating topography, ranging from 17 – 25 %.
- The Marginal & Small Farmers were unable to reclaim their lands due to financial constraints.

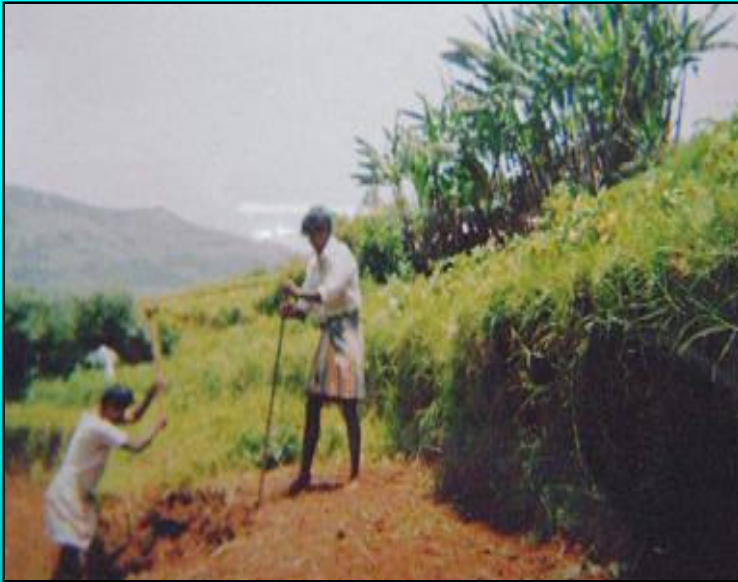
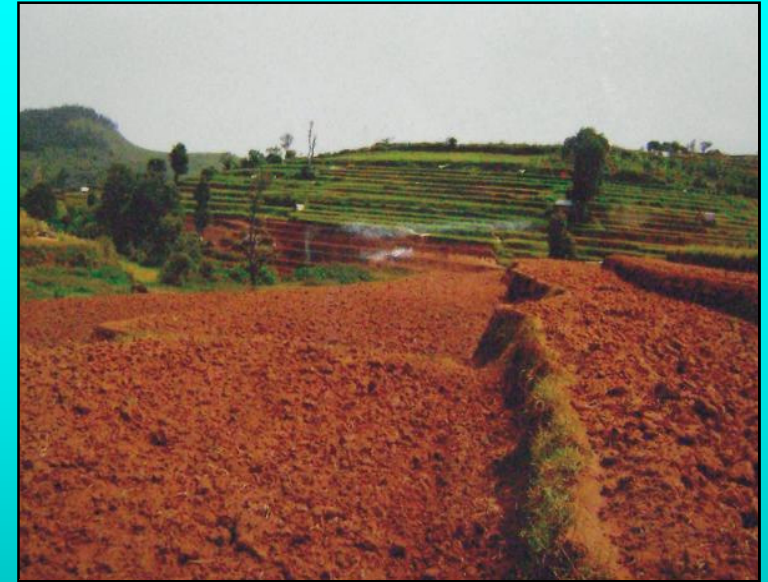
LAND LEVELLING

Elevation : 2105 Mts above MSL

- ❖ The work was done to reclaim uncultivable lands in the sloppy hills of the watershed in order to bring additional area under cultivation.
- ❖ To increase Vegetable Production in the area.
- ❖ After clearing the bushes, stubbles, stones, tree roots, the land was leveled.
- ❖ Earthen bunding was provided wherever necessary.

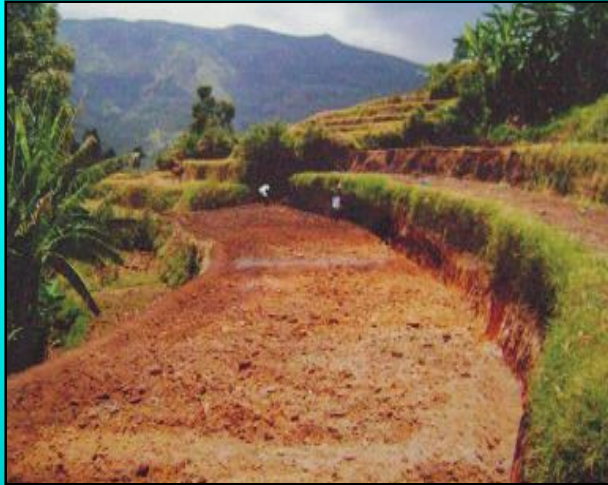
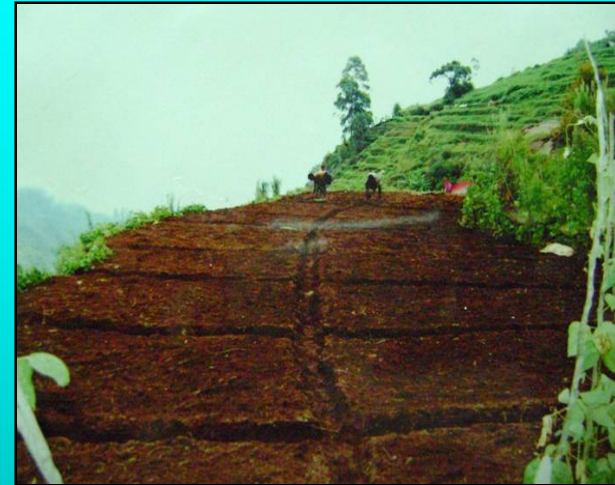
LAND LEVELLING

- **The land was leveled so as to raise irrigated crops.**
- **It retains the available runoff and reduces the erosion of the top soil.**
- **The initial ploughing with bullocks was done to loose the top soil to form field beds.**

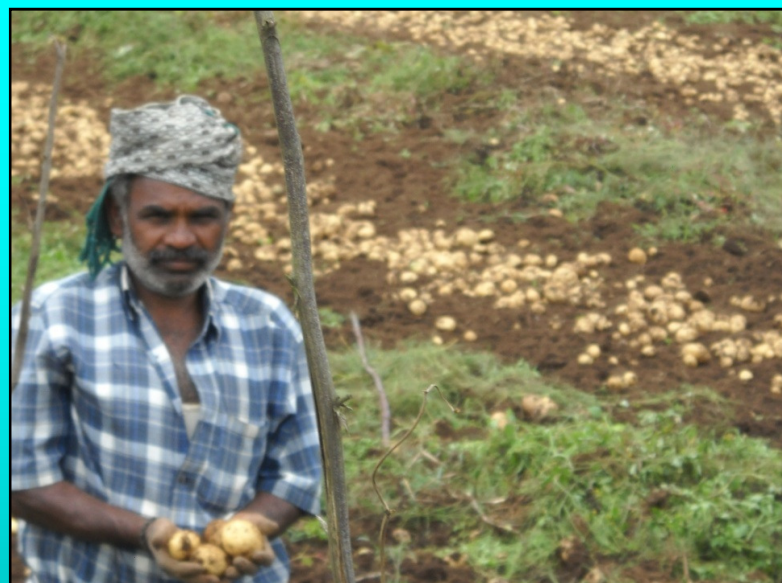
Velammal, D/o.Murugan, SF.No.505/1

Income from the field Before Land Development			NIL
Duration of the crop	90 - 110days	--	--
Cost of the seed materials	Rs.12500/ha	--	--
Cost of Cultivation	Rs.10000/ha	--	--
Yield/ha	4000 kg/ha	--	--
cost of the yield@Rs12/kg	Rs.48000/ha	--	--
After land reclamation by DPAP, income from the field (per Ha.)		--	Rs.25,500

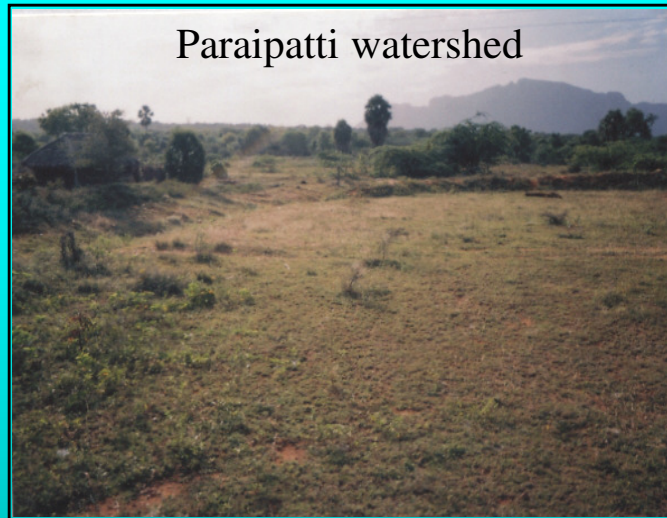
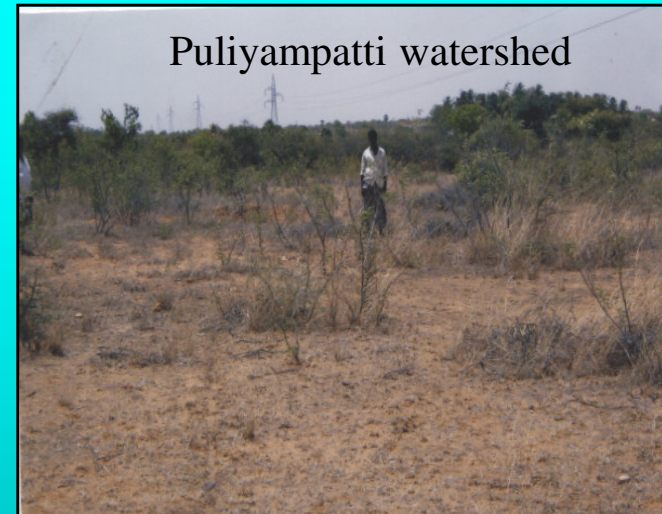
FORMATION OF FARM PONDS

Elumalai, S/o.Pitchai, SF.No.919

Thirupathi, S/o.Perumal,
SF.No.670/2

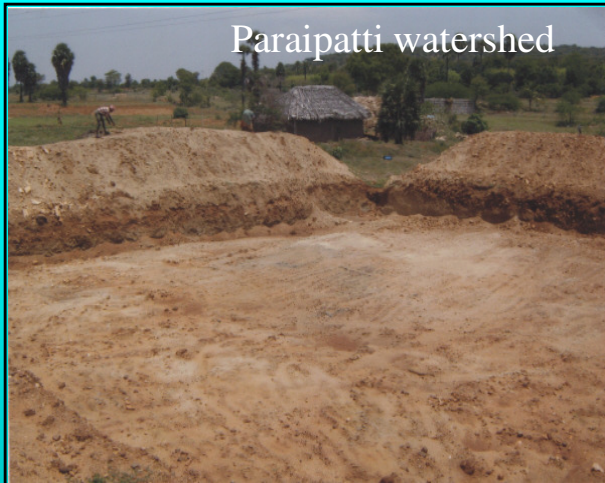
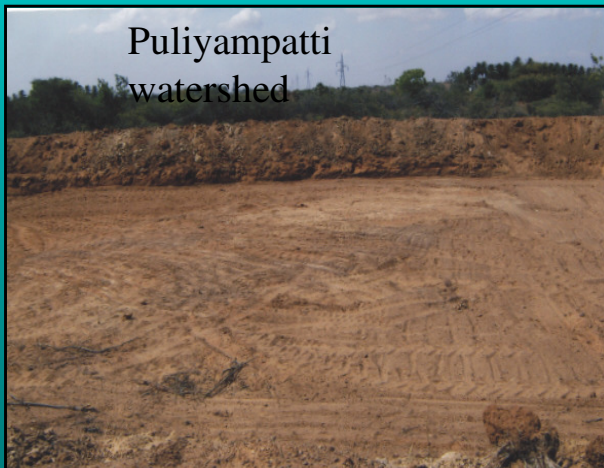
IWDP –VI - Guziliamparai Block – Dindigul District – TamilNadu

- Rain Water is harvested in the land.
- Wells benefitted are 7 Nos.
- To avoid percolation of water harvested, clay soil was spread in the Farm Pond.
- Timber crops are grown on the bunds.

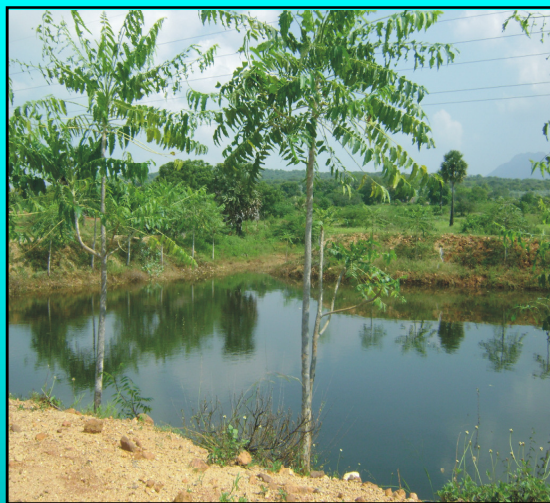
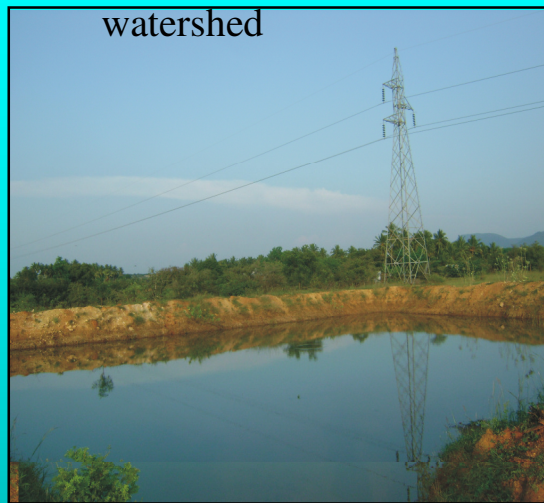
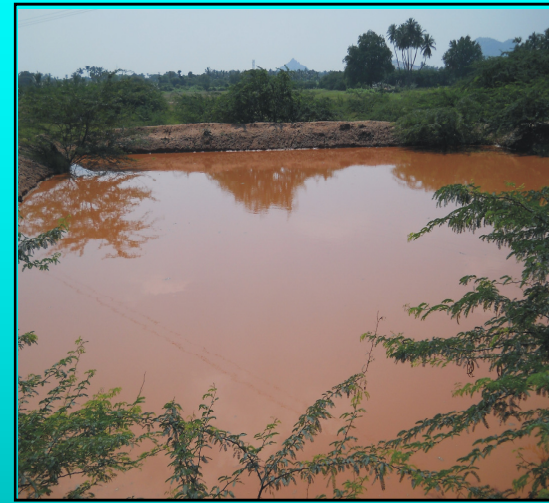
IWDP –VI - Guziliamparai Block – Dindigul District – TamilNadu

Paraipatti watershed

Puliyampatti
watershed

Karuthanampatti watershed

- ❖ During monsoon, the farm pond is filled to capacity of 5.15 lakh litre.
- ❖ Water level in 7 wells in the downstream of the farm pond is raised by 2 – 4 feet.
- ❖ Farmer Mr.Elumalai, S/o.Pichai watershed of Paraipatti happily says that he is now having high hopes to sustain the growth of the Gloriosa superba (Herbal Plant).
- ❖ The expected income is Rs.65000-Rs75000 during September2011.

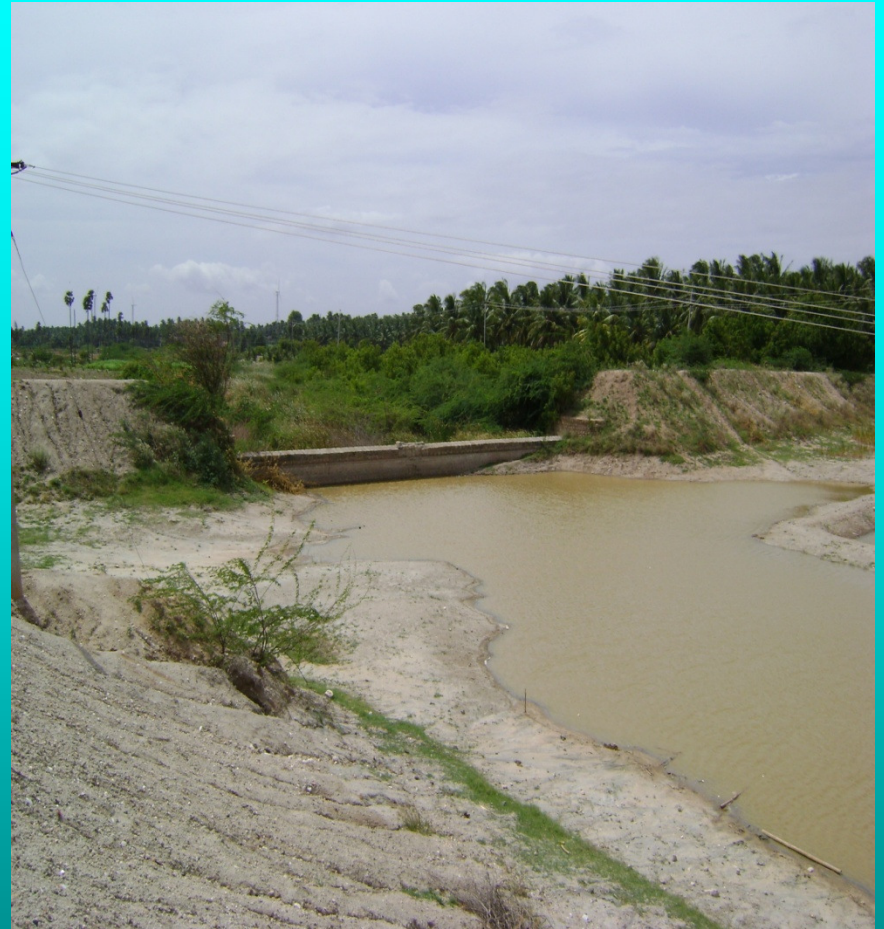
- In 50.9 per cent of the watersheds, the increase in cropping intensity is observed to be less than 10 per cent.
- While 10 to 20 per cent increase in cropping intensity is found in 29.8 per cent of watersheds,
- There was 19.3 per cent of watersheds have registered an increase in cropping intensity of more than 20 per cent.

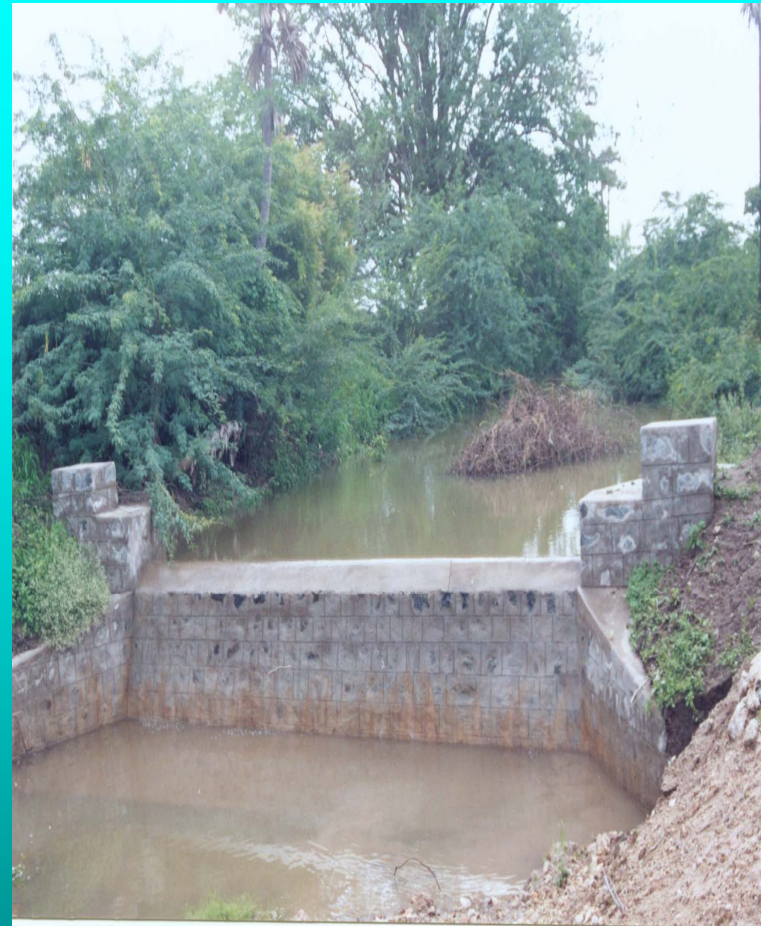
- watershed development activities generated significant positive impacts in the environment.
- The increase in water level in the wells is varied from 0.2 meter to 8.5 meters and this varied across seasons.
- Around 51.4 per cent of watersheds have less than two meters increase in water level in the wells.

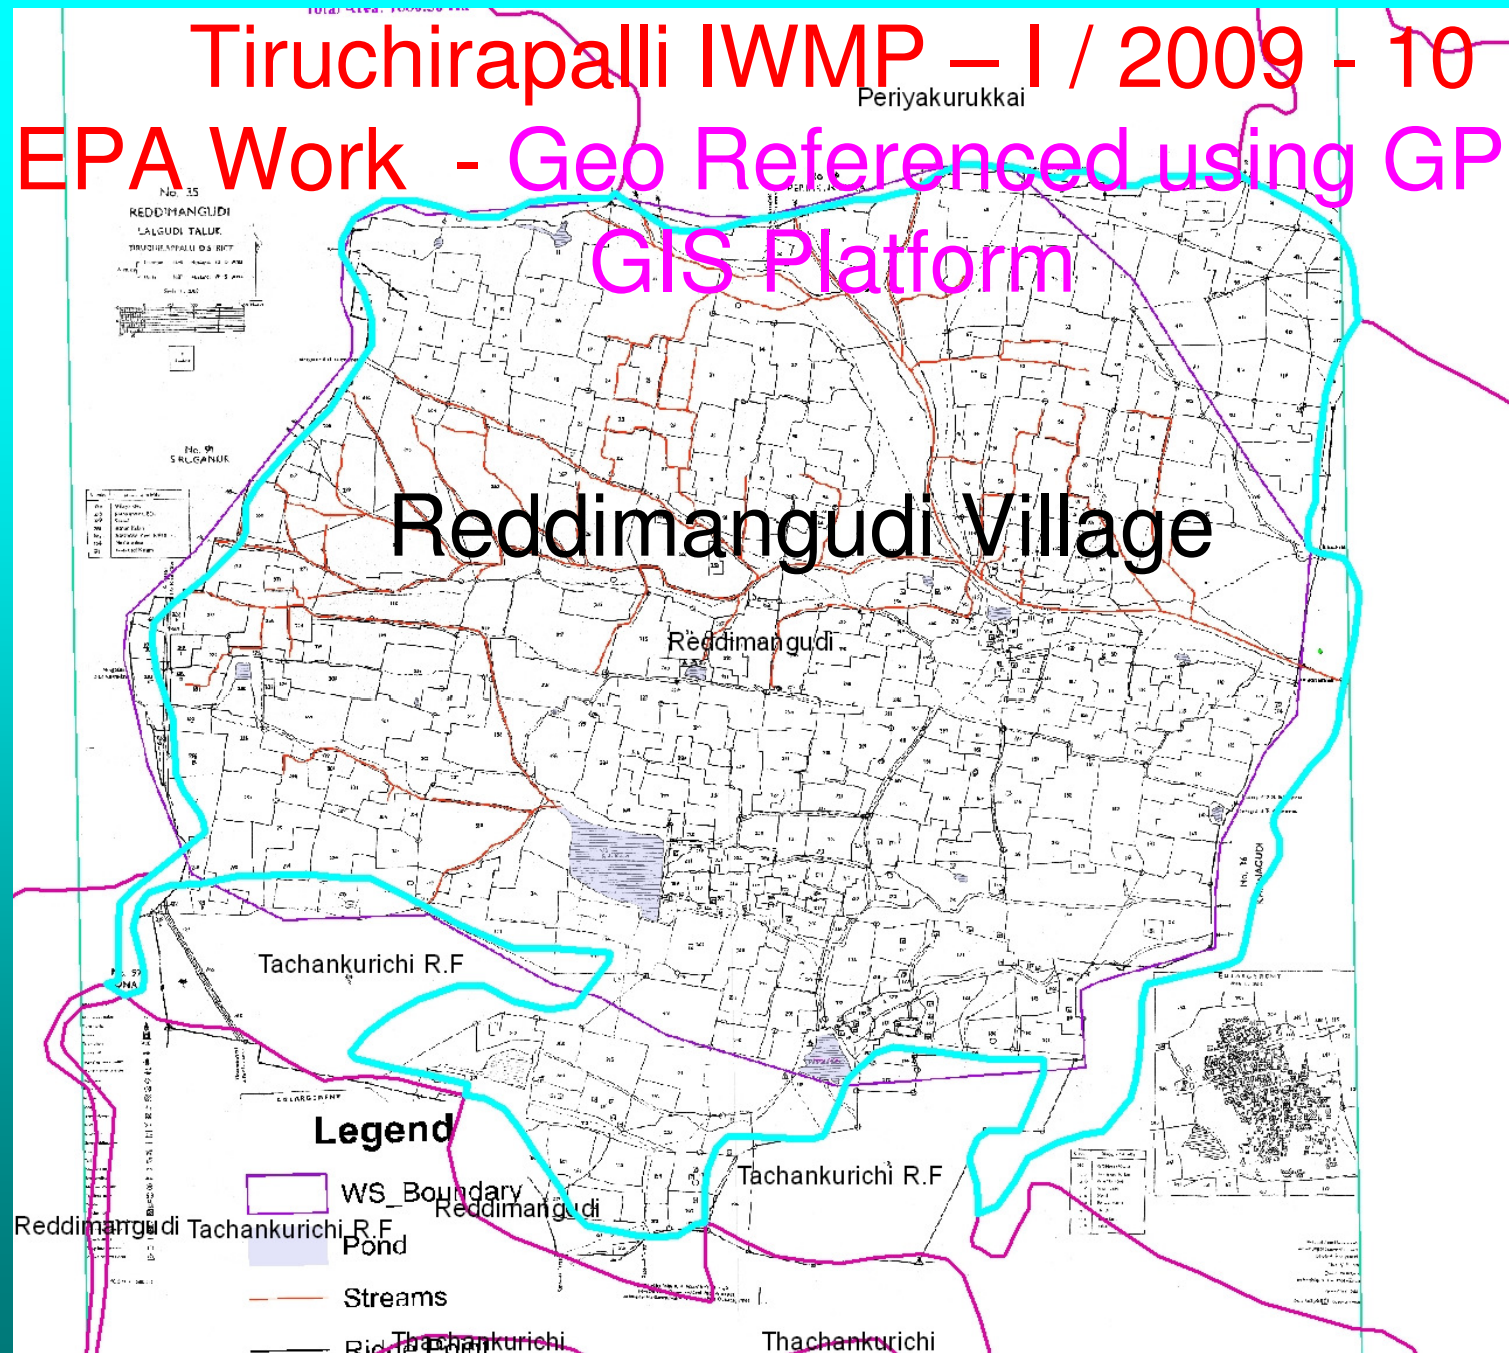
Reddimangudi Village

EPA Work - Geo Referenced using GPS in GIS Platform
