# Benefits/Issues and Status of WATSAN Systems

A Survey of WATSAN systems implemented in an  
IDWM project supported by Arghyam

September 2010

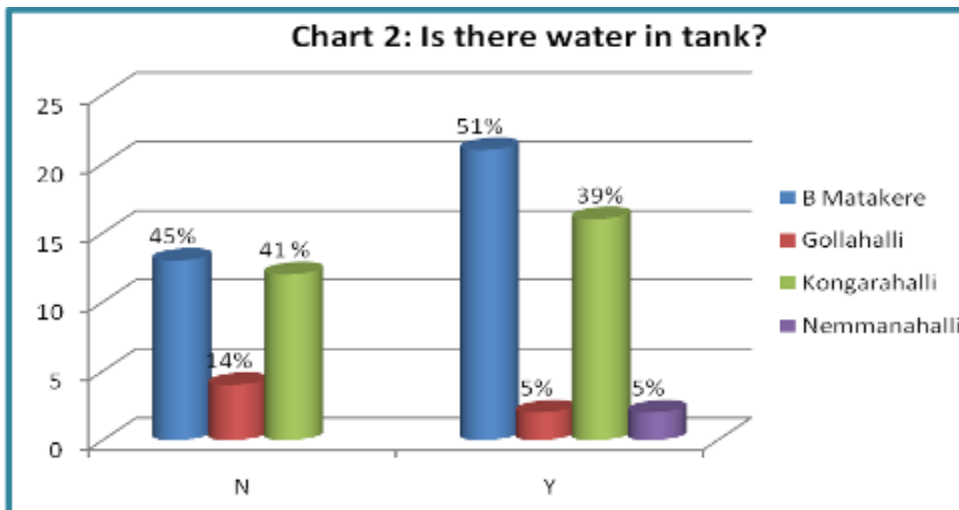
**Water in tank:** At the time of survey, around **59% (41 units)** had water in the tank. Out of these 41 units that have water in tank around 21 (51%) belong to B Matakere, 16 (39%) to Kongarahalli and 2 (5%) each in Gollahalli and Nemmanahalli.

59% RRWH have water in tank
