# **Ground Water Quality and Health Impacts in Bhalaswa, New Delhi**

**A report**

**Bhalaswa Lok Shakti Manch,  
and  
Hazards Centre, New Delhi  
2012**

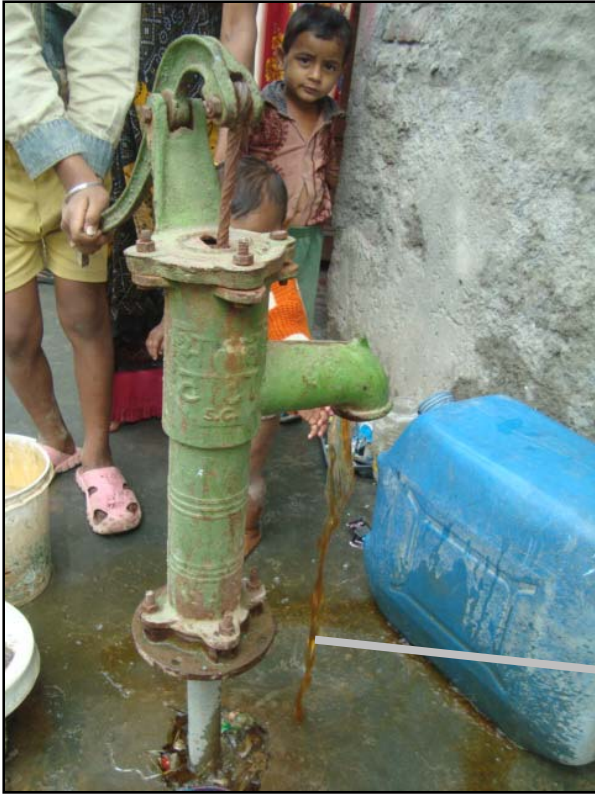
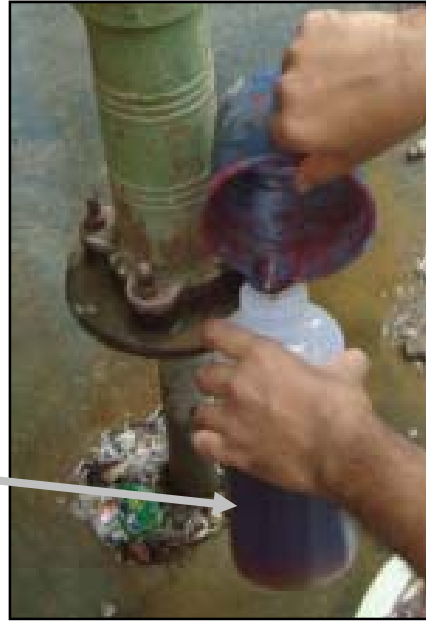
The photographs show the colour of water from a hand pump in Shradhanand colony

During the survey, people were asked about the visible characteristics of the water that they receive. A large number of people reported problems such as not obtaining clear water, but getting coloured water having sediments. For example, 82% people in Shraddhanand colony, 89% in Bhalaswa and 68% in Mukundpur and Nathupura said they received yellow coloured water. The people reported that on letting the water stand for some time, a layer of sediments is observed at the bottom. In some of the hand pumps near the landfill, the water that comes out sometimes is brownish-blackish in colour. Additionally, according to data from the Central Groundwater Board and the Central Pollution Control Board, groundwater in Bhalaswa is fresh water up to 30m-60m depth. However, 94% of the respondents said that the drinking water is salty in taste. Even in Shraddhanand colony, 77% of the respondents and in Munkundpur-Nathupura 87% of the respondents said that the drinking water is saline.

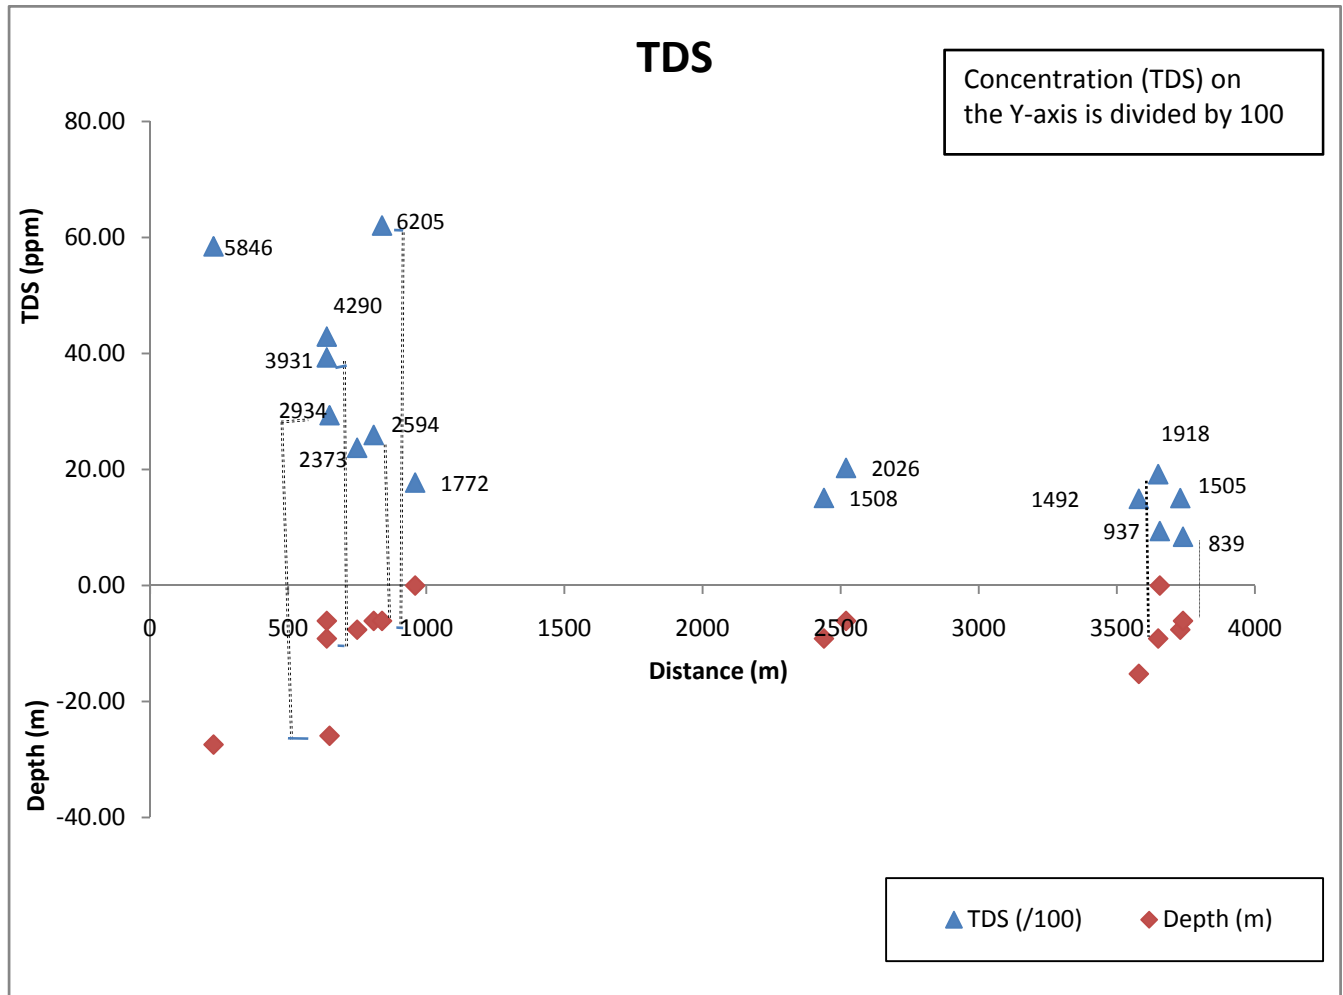
### TDS Concentration in Groundwater around Bhalaswa Landfill

It can be seen from the graph that the concentration of TDS in the groundwater samples decreases with increasing distance from the landfill. Of the groundwater samples taken, all of them exceeded the desirable TDS limit of 500 ppm, and seven of the samples exceeded the permissible limit of 2000 ppm. It was observed that the samples located in Shradhdhanand colony and Bhalaswa resettlement colony had high TDS, ranging from 2373 ppm to 5846 ppm. Sampling site 1 was closest to the landfill and had a very high TDS (5846 ppm). On average, the samples that were located less than 1km from the landfill had dangerous levels of TDS, whereas those located beyond 1km were comparatively safer.

The highest TDS was found at the sampling site 6 (6205 ppm). This could be because this site was located next to a drain that was an additional source of contamination. Additionally the depth of the water sample was not very deep (6.1 m); hence little purification could have occurred due to filtration by soil.

Samples located in Mukundpur - Nathupura had lower TDS, ranging from 836 ppm to 2026 ppm. However, sample 9 (2026 ppm) and sample 10 (1918 ppm) were located near drains and there could have been contamination from it.

TDS is only an aesthetic and technical factor; however a high concentration of TDS is an indicator that harmful contaminants, such as iron, manganese, sulphate, bromide and arsenic, can also be present in the water. This is especially true when the excessive dissolved solids are added to the water as human pollution, through runoff and wastewater discharges. According to the BIS standards (1991), the desirable limit for drinking water is 500 ppm, and the maximum permissible limit is 2000 ppm. Water containing TDS more than 500 mg/L causes gastrointestinal irritation. Young landfills are characterized by leachate of high TDS.

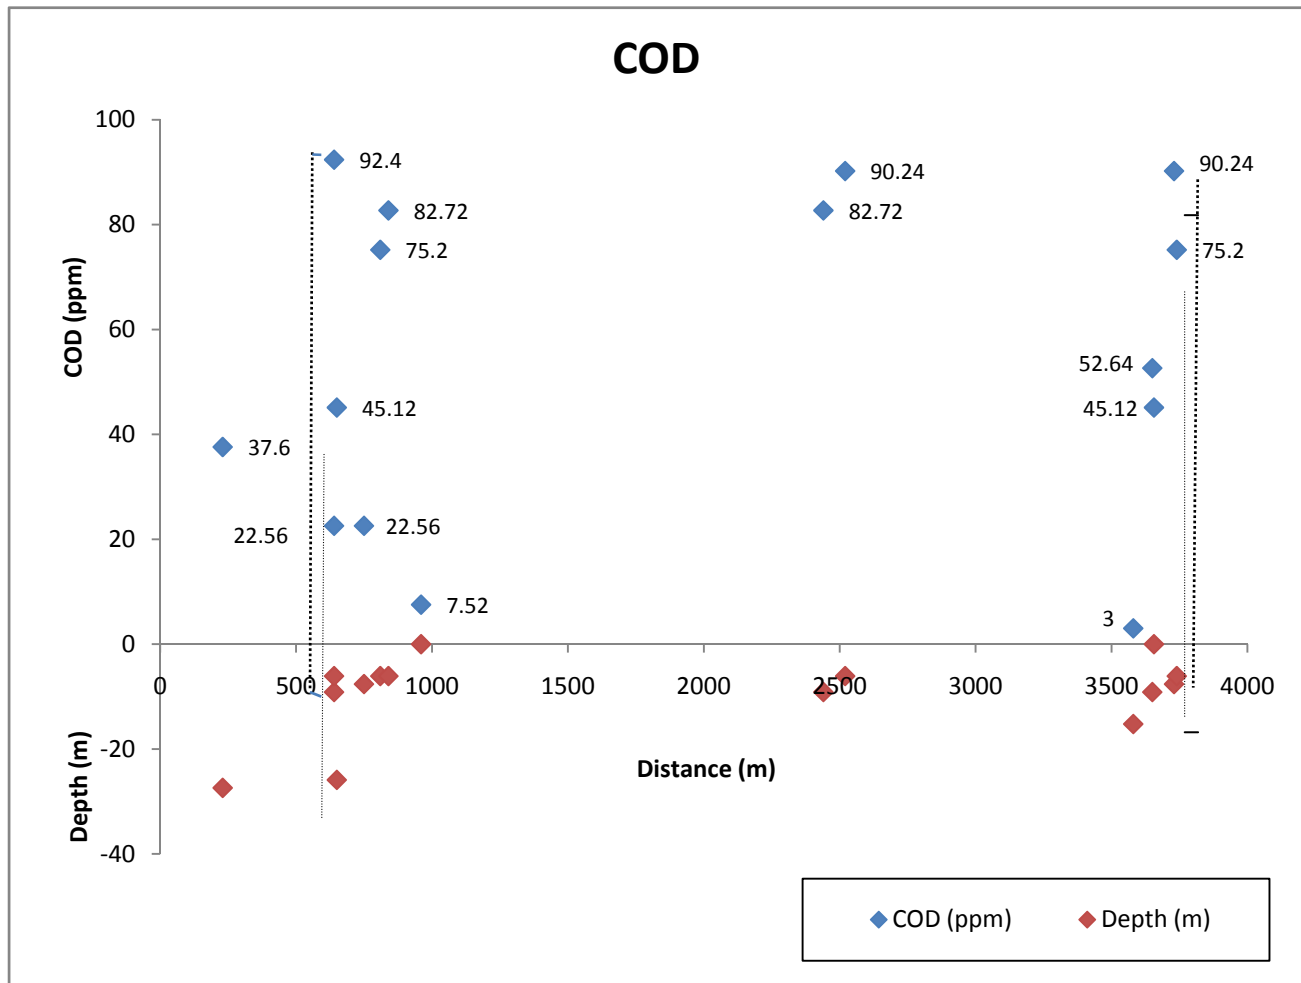
COD Concentration in Groundwater around Bhalaswa Landfill

COD is a parameter that is usually associated with sewage, and not drinking water, or water that is used for domestic purposes. Thus, no guidelines have been issued by the Bureau of Indian Standard (BIS). The WHO guideline for COD in drinking water is 10 mg/L. Only two samples, Sample 10 and Bhalaswa lake water have values less than the standard.

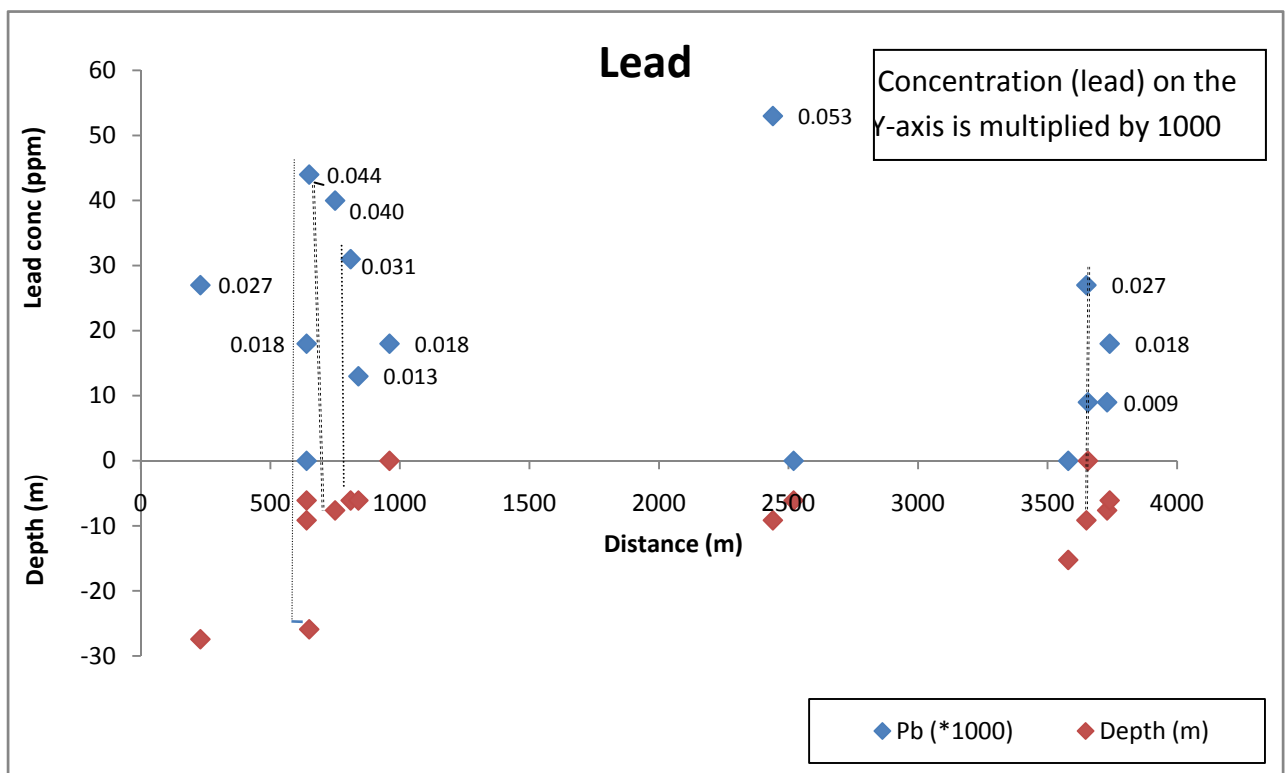
Lead Concentration in Groundwater around Bhalaswa Landfill

The WHO guideline for lead in drinking water is 0.01 mg/L (ppm). Of the groundwater samples tested, nine of the samples tested had lead concentration greater than the WHO guidelines. According to the BIS, the maximum permissible limit for lead is 0.05 mg/L. Only sample 8 had lead concentration greater than the permissible level according to BIS standard. Of the samples tested, the highest concentration of lead was found in sample 8 (0.053 ppm).

Of the samples tested, the samples from Shradhanand and Bhalaswa had greater lead concentrations, ranging from 0 to 0.044 ppm. The samples located farther from the landfill had lower concentration of lead. Thus, the landfill could be the source of contamination of groundwater by lead.

Possible sources of lead in the landfill could be lead batteries, e-waste, construction waste (having lead-based paint) and chemicals for photograph processing. Leaching of lead from landfills has been studied in other cases as well.

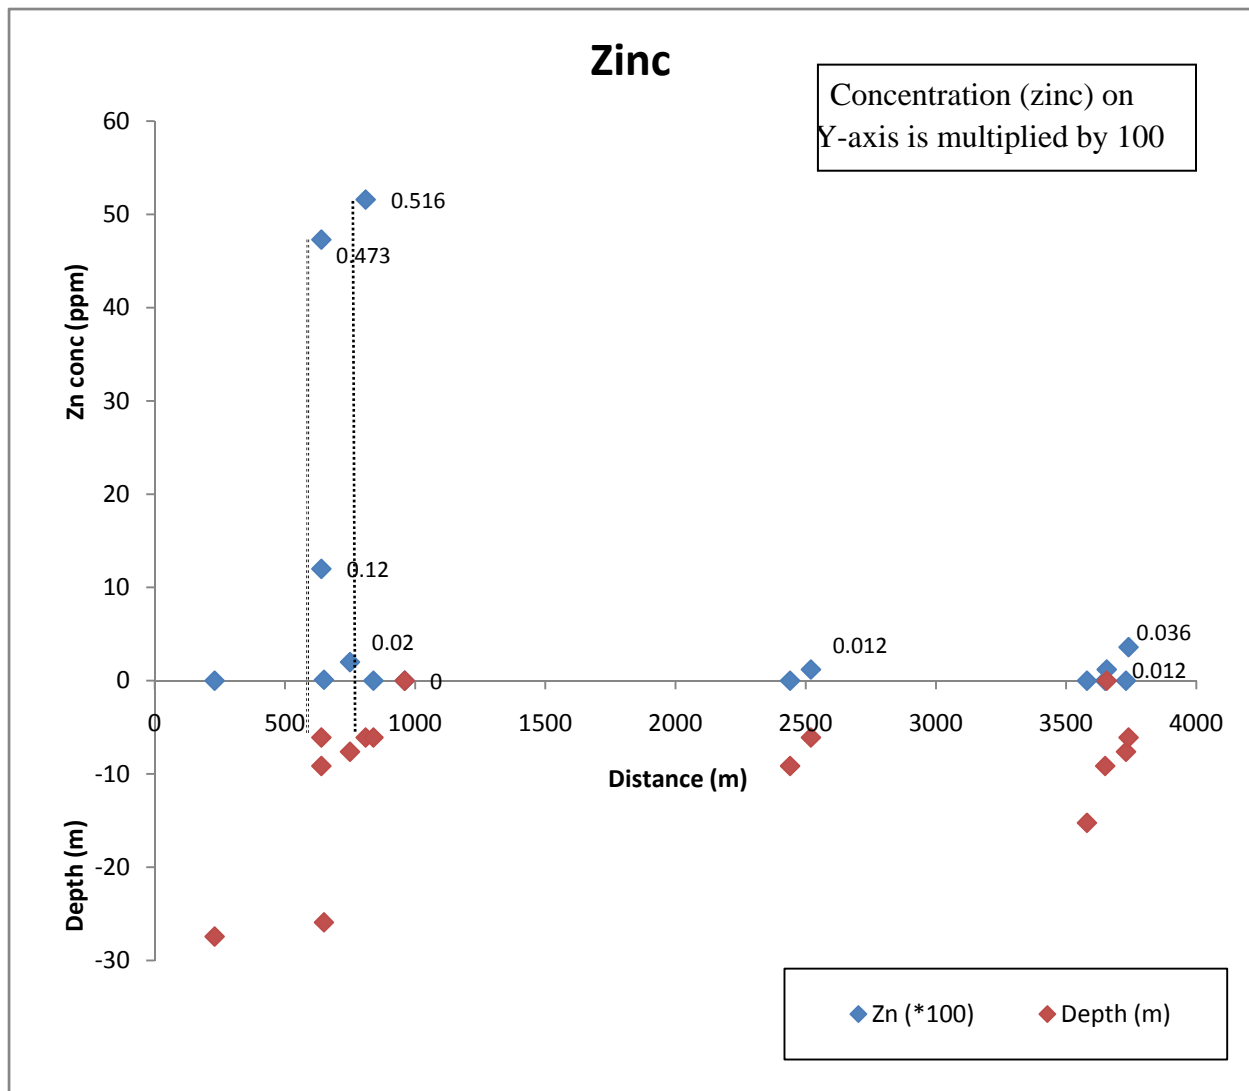
Zinc Concentration in Groundwater around Bhalaswa Landfill

The permissible level of zinc in drinking water is 15 mg/L. The concentration of zinc found in the samples tested ranged from below detection limit to 0.516 ppm. Thus all the samples had zinc levels below the permissible limit. In seven samples, they exceeded the levels normally found in groundwater (about 0.01 ppm).
